HAZARD ALERT

<p>Concern: Kubota FOPS weld's breaking away from mounting bracket's</p> <p>SAF 079 #: 035208</p>	<p>Initiating Plant: T-1 Mine</p> <p>Awareness Date: Nov.13/07</p> <p>Alert Date: Nov.14/07</p>
---	--

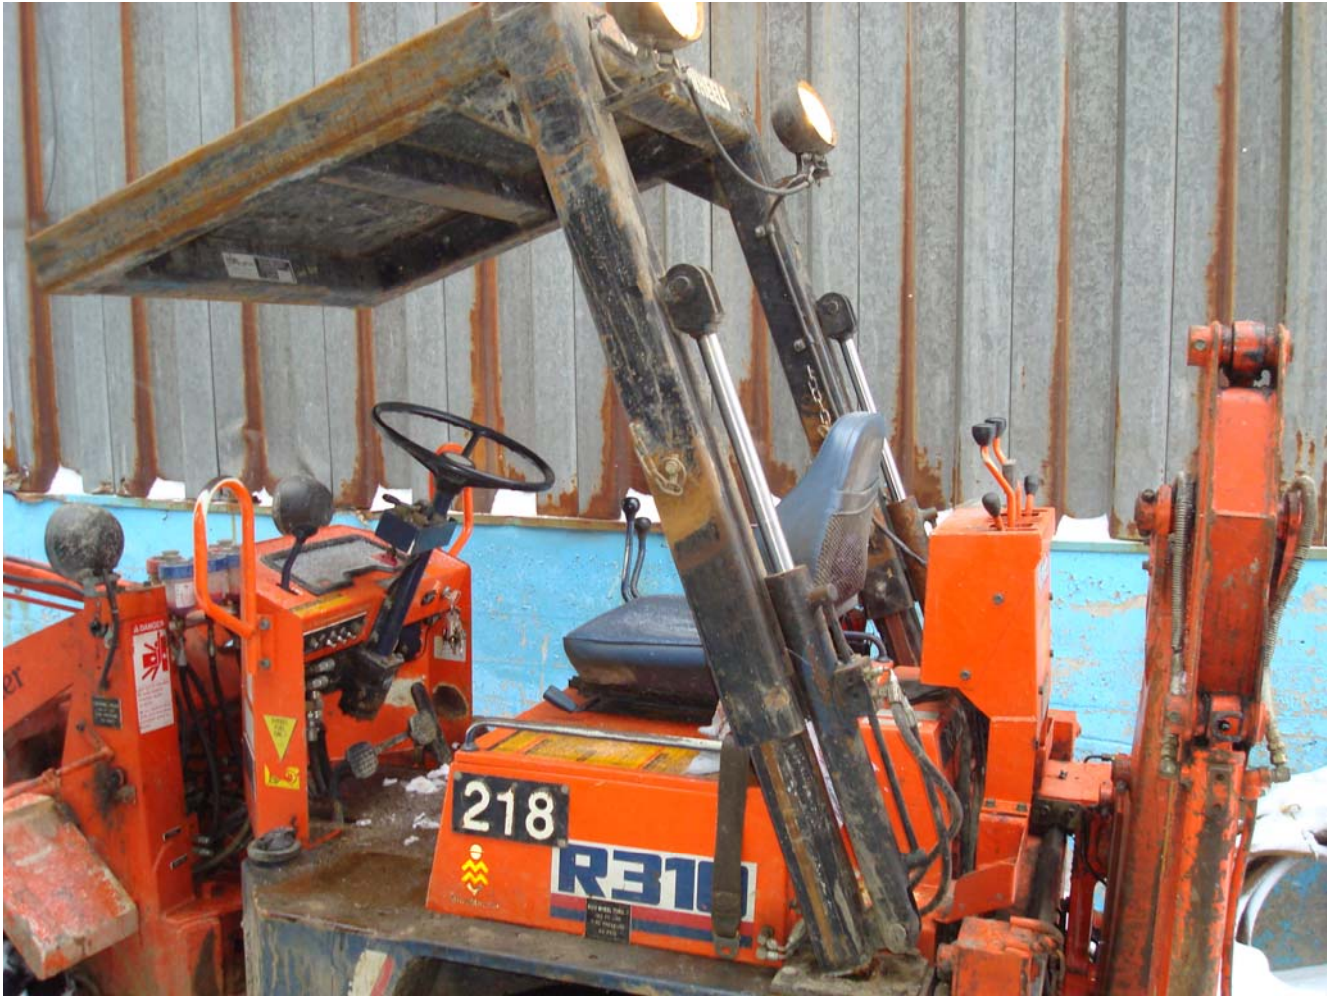
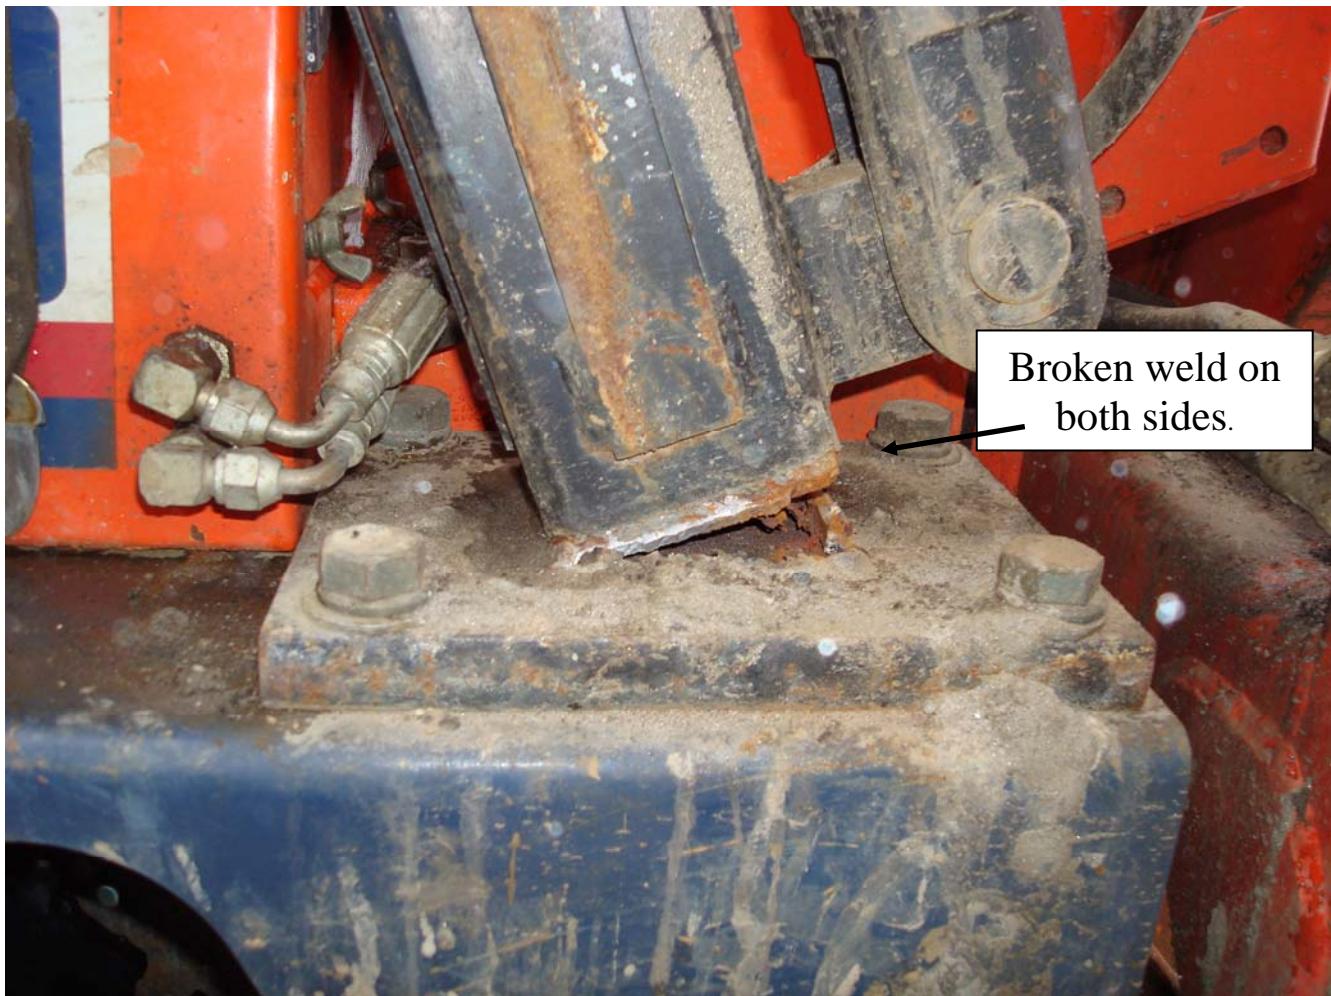
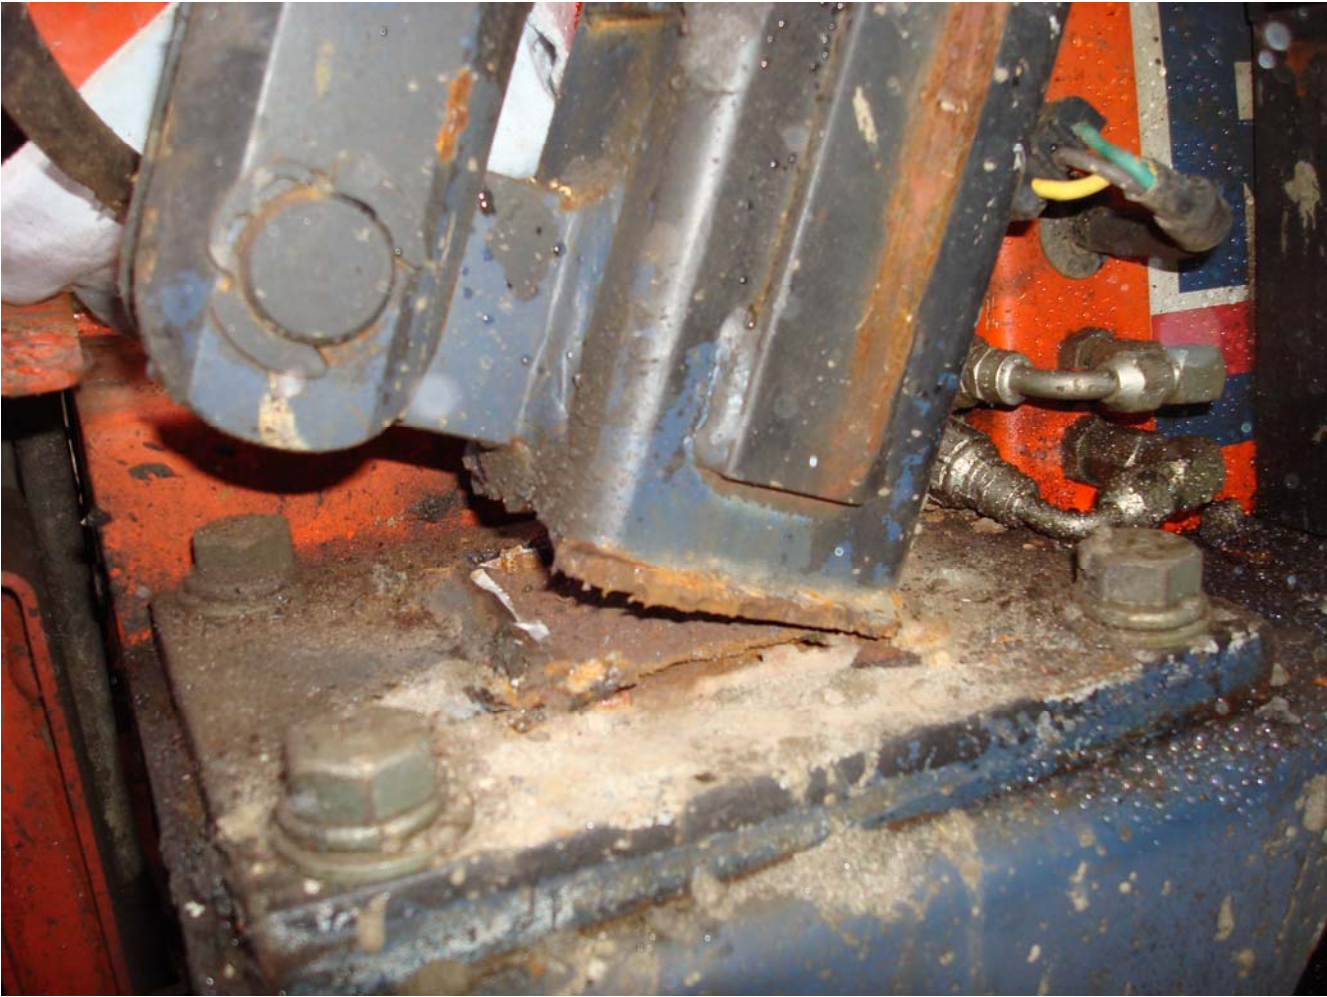
Photos Attached: 3 photos attached.

Employee did an initial check of the # 255 Kubota at #8 butler bldg. He then drove the Kubota a very short distance to #1 butler where he was to prepare for a task. When the employee applied the manual foot brake, the FOPS broke away from the body of the Kubota and fell forward. The initial investigation has discovered that the weld(s) broke on the mounting brackets.

- Make hazard aware to all crews, and to check weld for crack's on all Kubota FOPS mounting brackets.
- Ensure that a visual check of the FOPS structure be included as a checklist item on a regular Preventative Maintenance (PM) check.
- Review Preventative Maintenance inspections of FOPS structures to ensure they are comprehensive and include Non Destructive Testing (NDT) methods to ensure component integrity

- Make hazard aware to others, so that operators adjust their initial checks to take into consideration the welds on Overhead and Rollover protection in order to minimize risk.
- Ensure that weld inspections of critical components are a line item of routine inspections conducted by competent personnel.
